NRW MANAGEMENT STRATEGY

Technical Assistance to Cagayan De Oro City Water District on
Non-Revenue Water Reduction Strategy and Implementation

Subcontract Agreement No. 893-S15-013

September 2016

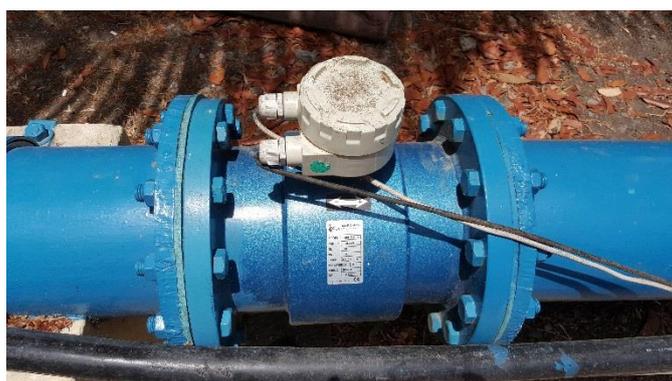
There is no electrical conduit that shields the cable connections between the converter (display) and the meter (sensor). The meter cables are very vital for supplying currents through the meter coils and it also convey signals from the sensors to the converter. These cables are constantly exposed from direct sunlight, seasonal weather changes and chemicals (chlorine) for water treatment which can damage its insulation components and later on could affect the reliability of the supply volume measurements.

Photo 2: No Conduit and Grounding System (PW #10A)

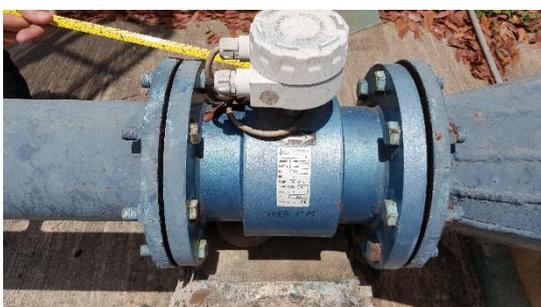
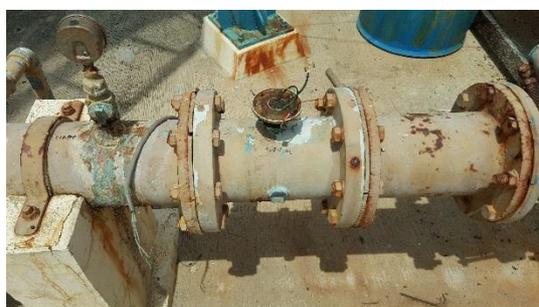
The production well #15 and #24 supply meters do not have converters/displays. As per COWD production department, the converters were damaged during Typhoon Sendong. There is a regular flushing exercise carried out in these two production wells. However, there is no means of quantifying the water discharge due to unavailability of the meter converters.

Photo 4: No Converters/Displays (PW #15 and #24)

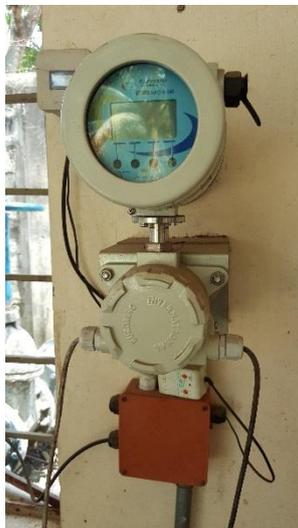
The converter of the supply meter in production well #10A is totally blackout. No records of supply data found in the meter reading ledger. As per COWD technician, the internal battery is drained that is why the converter doesn't have power source to display the totalizer.

Photo 5: Blackout Display

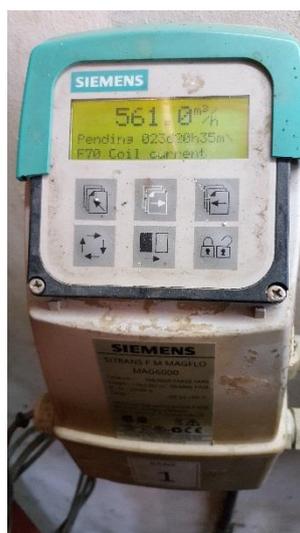
A fault code “F70 Coil Current”, which means that there is an alarm on the supply meter’s coil current, was observed in Macasandig old booster bank #1. The alarm has been pending for more than a month.

Photo 6: F70 Coil Current Fault Alarm at Macasandig Old Booster Bank #1

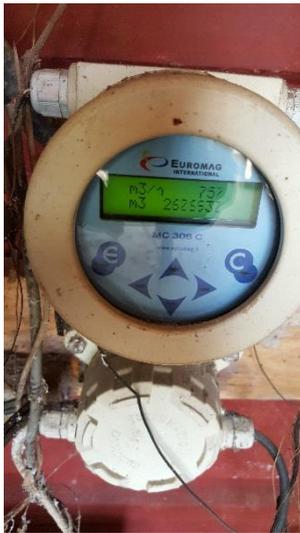
Photo 9: Production Well #18 Meter Converter

At the moment, production well #18 is only used for back-up water source. However, from time to time, COWD does water flushing 30 minutes to 1 hour a day. It is being observed during the visit that the converter’s register display particularly the totalizer and flow rate indicators were running (accumulating) even though the production well was shutdown. This only means that there is over-reading of the supply input volume of production well #18. Aside from this problem, the converter display is also fading which makes it very hard to read. The succeeding photos show the production well #18 supply meter.

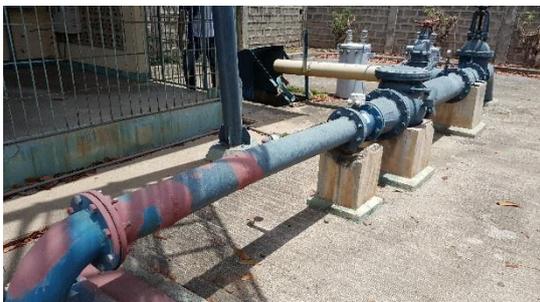
Photo 11: Production Well #15 Meter Assembly

The supply meter in production well #15 has never been used for the past years as this facility was damaged during the Typhoon Sendong. Regular flushing is periodically done in this facility to prevent water quality issues. These withdrawals have not been quantified because the meter doesn't have the converter. Another issue why this facility couldn't be operated is due to unavailability of the power supply. Photos of production well #15 supply meter and assembly can be seen below.

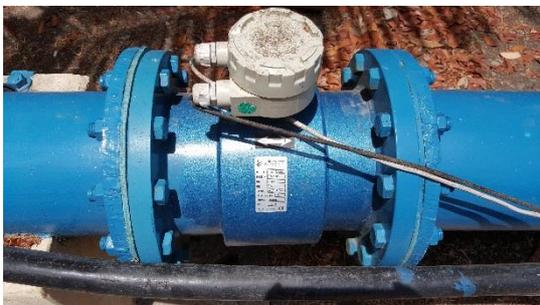
Photo 13: Production Well #10A Supply Meter

There are no available straight pipe distances at both sides of the meter. The power/signal cables between the meter sensor and converter are stretched out which can break the internal wires and loose its signal in the long run (see Photo 13).

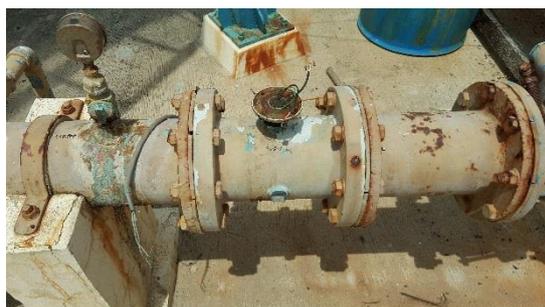
Photo 16: Production Well #24 Supply Meter (Detached Converter)

Following the allowable straight pipe distances 10D and 5D for upstream and downstream (U10D5), the current meter’s assembly in production well #24 is lacking of straight pipe distances. The succeeding photos show the production well #24 supply meter and its assembly.

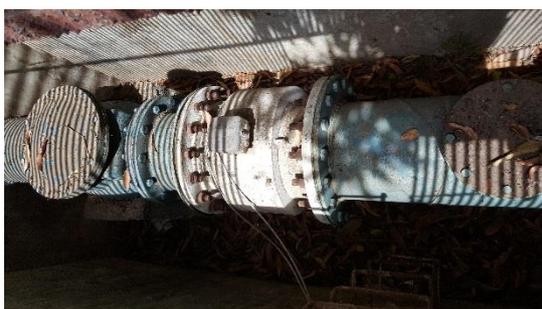
Photo 20: Balulang Booster (Bulua Line) Supply Meter

It is observed that the flow rate decreased by 72 m³/hour (or 1,728 m³/day). This supply measurement changes should be also considered in the NRW water balance calculations. The following photos show the Bulua Line’s supply meter and converter.

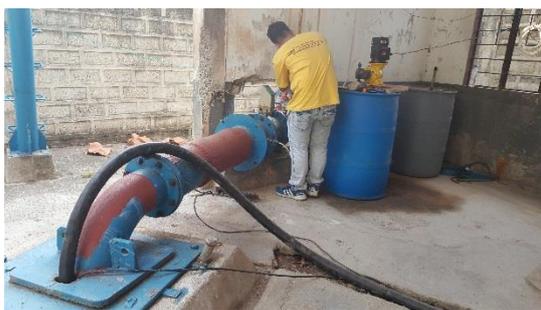
Photo 22: Production Well #11 Supply Meter Assembly

An alarm code “W30 Overflow Max” was observed during the inspection. This type of alarm means that the current flow rate has reached the maximum threshold setting of the meter. It is being said by the COWD technician that it happened because there was an upgrade made on the submersible pump installed in the production well facility. However, the alarm has no direct effect on the reliability of the measurement. The succeeding photos show the supply meter assembly and converter of production well #11.

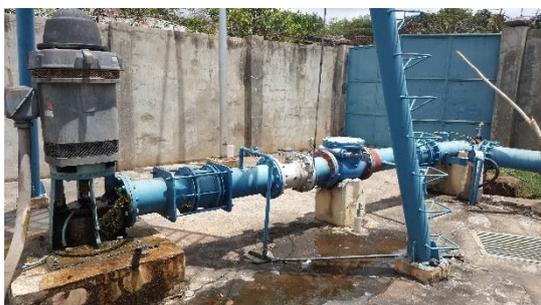
Photo 30: Production Well #28 Supply Meter Assembly

The supply meter installed in production well #28 is properly sized. Limited straight pipe distance has been observed on both sides of the meter. Water leakage coming from the pump motor was seen during the site inspection. The succeeding photos show the supply meter and assembly of production well #28.

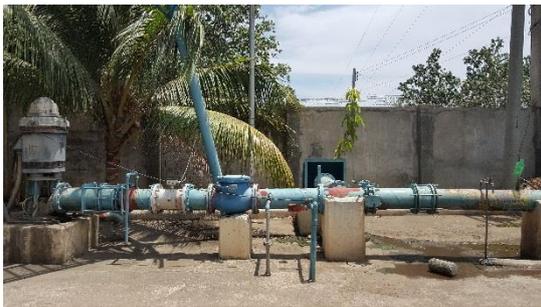
Photo 32: Production Well #29 Supply Meter Assembly

The meter installed in production well #29 is properly sized. Limited straight pipe distance has been observed on both sides of the meter. The converter’s protective cover is missing. The absence of protective covering could make the converter vulnerable to dust and water ingress. It also seen that there is continuous dripping of treated water from the flushing line which perhaps due to untightened valve. The succeeding photos show the supply meter assembly, converter and water dripping at production well #29.

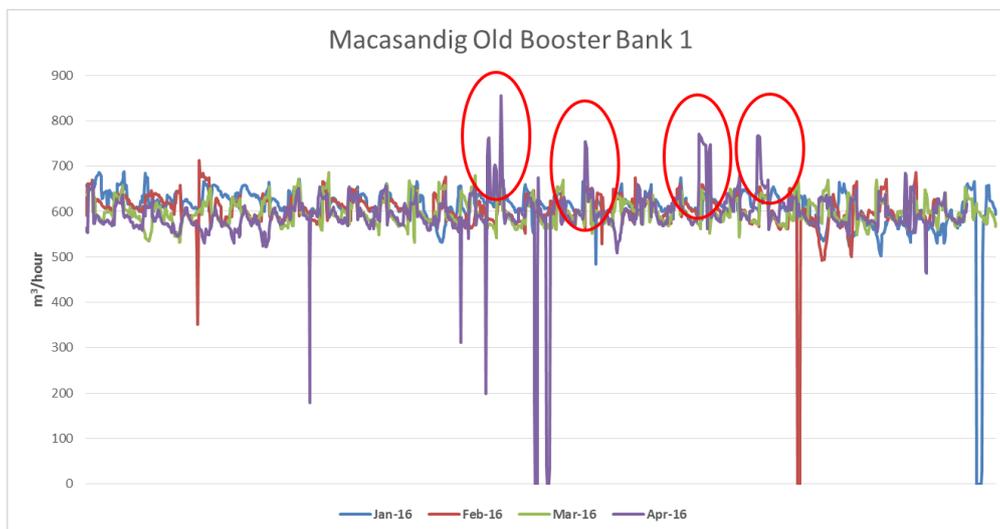
Figure 2: Logged Flow Data for the Past 4 Months (January – April 2016)

The meter installed in Macasandig old booster bank #1 line is slightly oversized as the estimated velocity is around 0.64 m/s. But since the existing meter is a full-bore electromagnetic type, it should be able to measure the supply input volume accurately because this type of meter is known in having a good turndown ratio. The meter has enough straight pipe distance on both sides. An alarm on the converter was observed during the field audit. The display showed “F70 coil current” alarm indicating that there is a problem on either the sensor coil or the cable connections. The alarm started to manifest in mid of April 2016. It has never been resolved since the time the alarm was started. The monthly logged flow data with 30-minute sampling interval has been plotted and compared to observe whether the alarm has direct influence on the measurement performance of the supply meter in Macasandig old booster bank #1. The following figure shows the monthly logged flow data from the supply meter.

The logged flow data for the month of April 2016 shows sudden flow fluctuations which has never been occurred in the past three months. This could be due to the alarm that has manifested in the same month where the fluctuations were observed. However, this needs to be checked and verified by accredited Siemens technician to further understand the source and effect of the alarm.

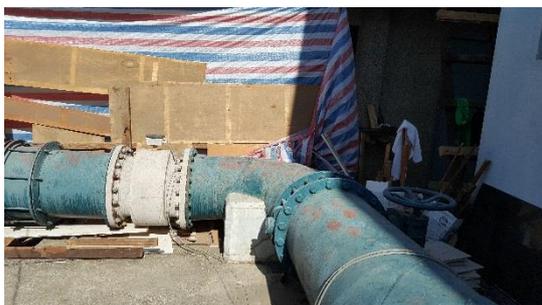
Photo 39: Macasandig New Booster Supply Meter Assembly

No data can support whether the supply meter in this facility is in the right size. The supply meter doesn’t have straight pipe distance at the upstream. A flange-ended bend is fitted at the upstream side of the meter which leads to absence of required straight pipe distance. The bend could create swirling flow effect through the supply meter. Excessive swirls through the supply meter causes inaccuracy on the measurements.

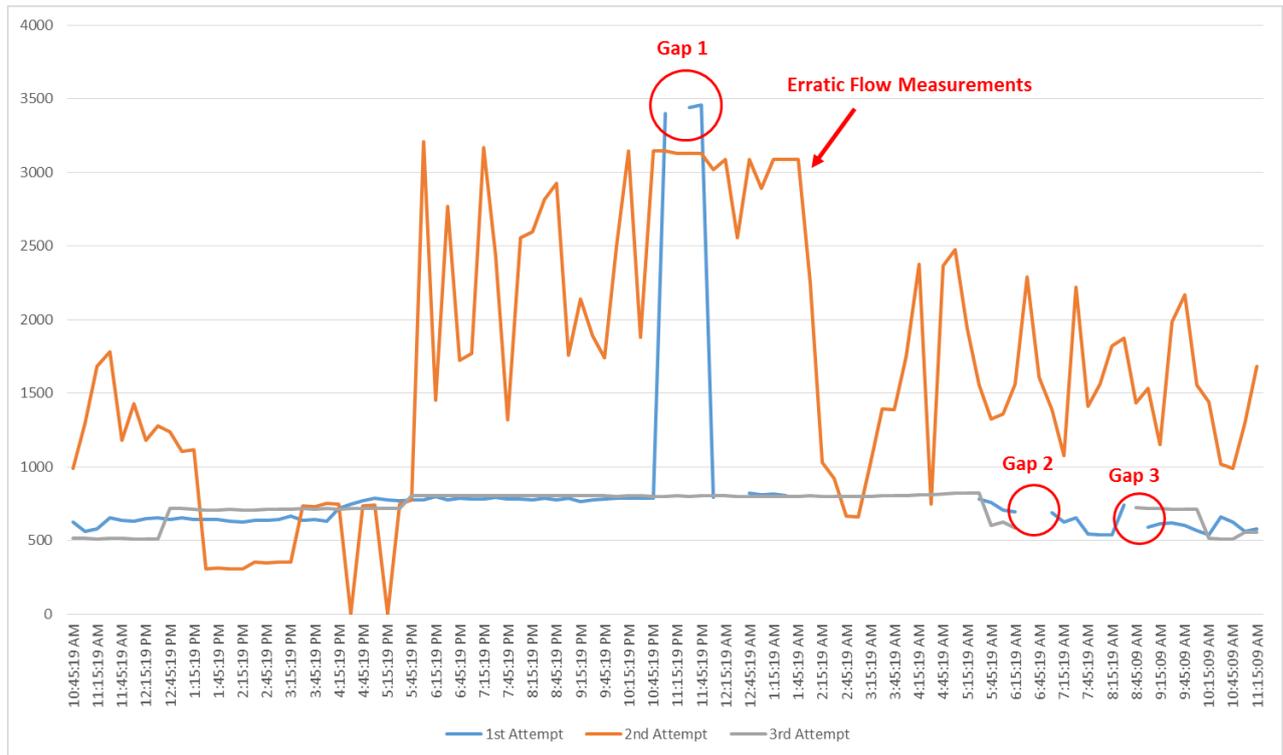
Figure 4: Result of the Three Measurement Attempts in Bulua Line

Several attempts on ultrasonic meter installation have been carried out in Bulua Line supply meter due to ultrasonic meter failures and erratic readings. The first attempt had 5-hour downtime (measurement gaps) on ultrasonic meter due to battery drained. The second attempt gave erratic flow measurements that had doubled the normal supply input volume of Bulua Line. The third attempt has become close to realistic figures except for 2-hour downtime because of battery drained. The following figure illustrates the three flow measurement attempts in Bulua Line.

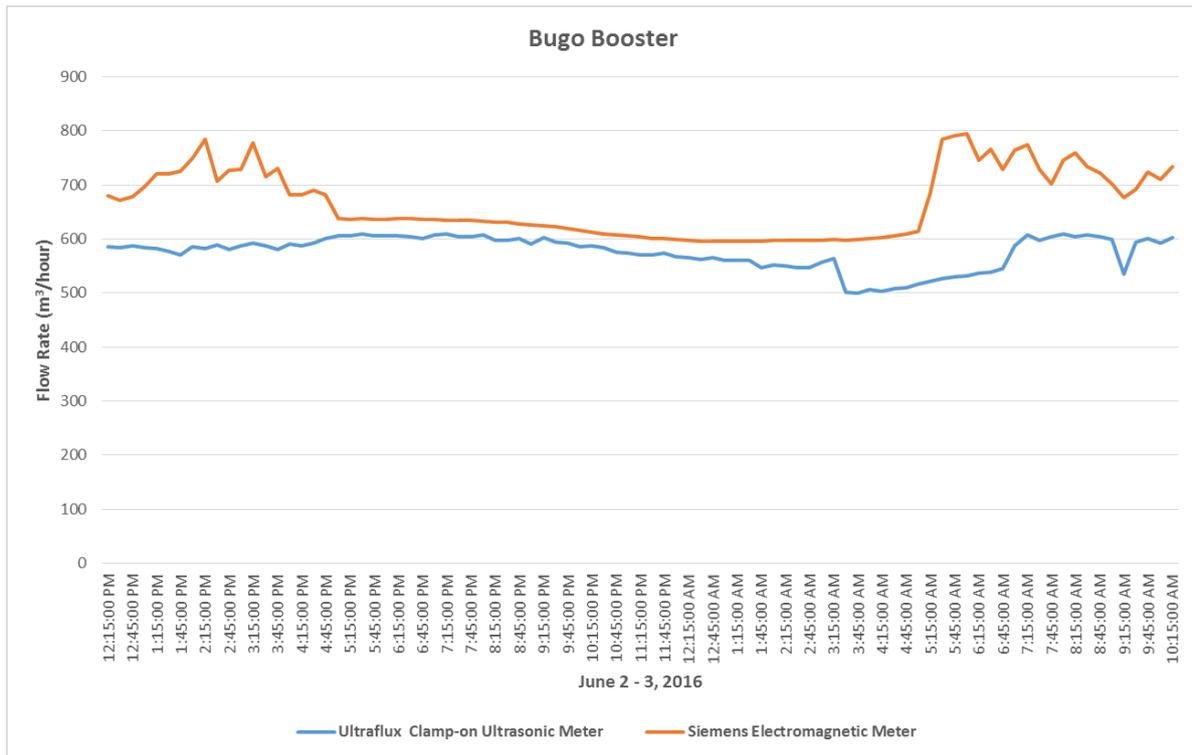
Figure 6: Bugo Booster Meter – Flow Measurement Comparison

The ultrasonic meter was installed on a bridge crossing pipe which is in line with the outlet pipe of the Bugo Booster. The bridge crossing pipe is not the ideal location where the ultrasonic should be installed as air pockets might be entrapped inside it. However, there is an air valve is installed on the pipe to release the air that is entrapped in the pipeline. This bridge crossing pipe is far from the main outlet of Bugo Booster. But the representative from COWD confirmed that there are no off-takes connected between the Bugo Booster outlet pipe and the bridge crossing pipe as this might possibly contribute significant measurement variance in the supply meter verification.

After analysing the two measurements on the graph, it is observed that there is measurement variance of 13.4% between the reference meter and the meter under test. The supply meter, which is the meter under test, measured more water supply compare to the reference meter (ultrasonic meter). Therefore, the supply meter is over-registering by 13.4% with respect to the reference meter. The following photo shows the actual installation of the clamp-on ultrasonic on the bridge crossing pipe.

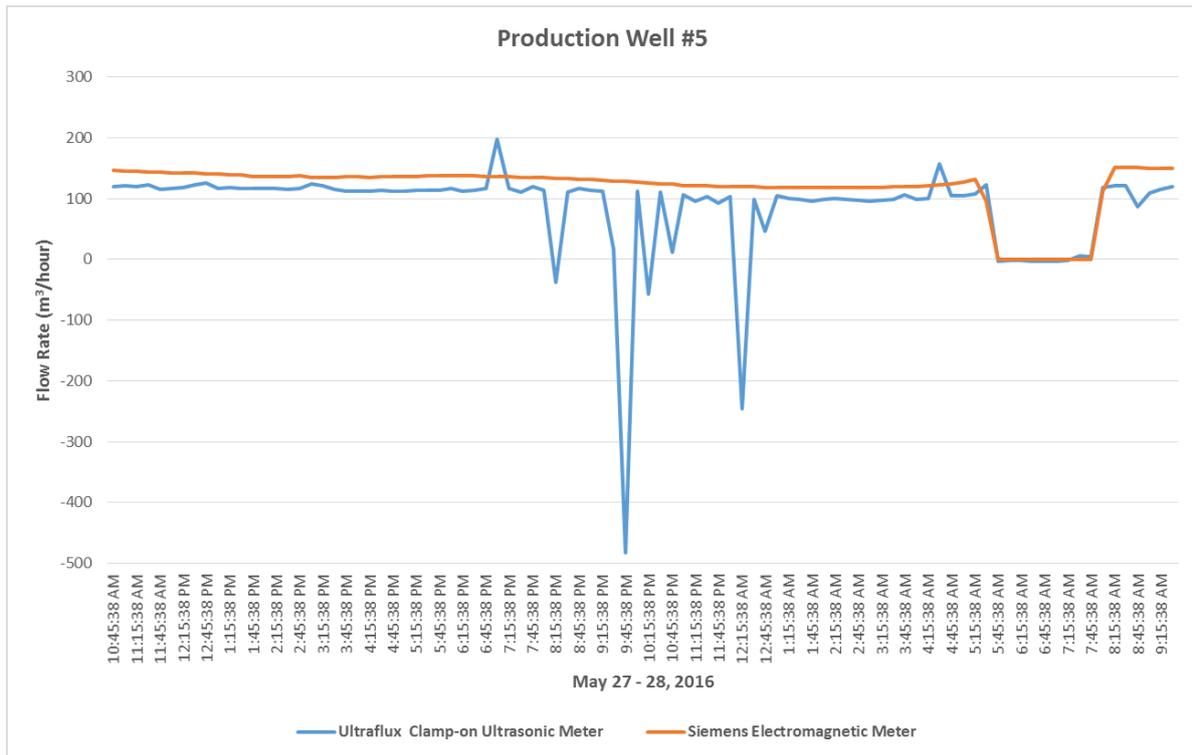
Figure 9: Production Well #5 Meter – Flow Measurement Comparison

There is a significant over-registration rate observed on the supply meter in production well #5. The production well #5 supply meter is over-registering by 28.3% when compared to the measurements collected by the reference meter (ultrasonic meter). Aside from high over-registration rate occurring on this supply meter, there are also back flows observed through the supply pipe outlet. The back flows contributes to the increase in measurement variance between the meter under test and the reference meter. It is quite impossible to have back flows through the supply pipe outlet because there is check valve fitted in the upstream side of the supply meter. This needs further investigation to determine the occurrence of back flows in the system.

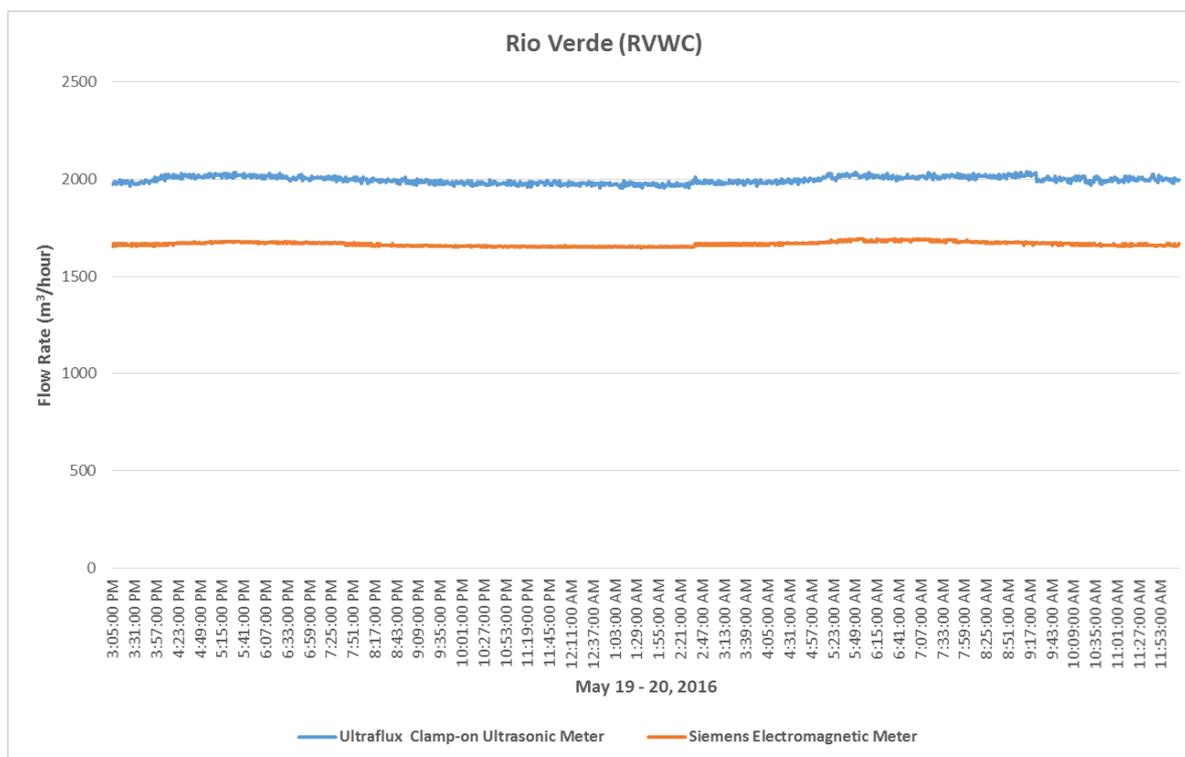
Figure 10: Rio Verde Meter – Flow Measurement Comparison

Comparing the logged flow rate from the reference meter and meter under test, there is measurement variance of 19.8% observed between the two flow measurements. The reference meter (ultrasonic meter) measured more water supply compare to the supply meter (meter under test). As a result, the supply meter installed in Rio Verde outlet line is under-registering by 19.8%. The measurement variance is almost consistent throughout the 24-hour measurements. The measurement variance observed will be significant when it is translated into supply input volume as Rio Verde is one of the COWD major water source.

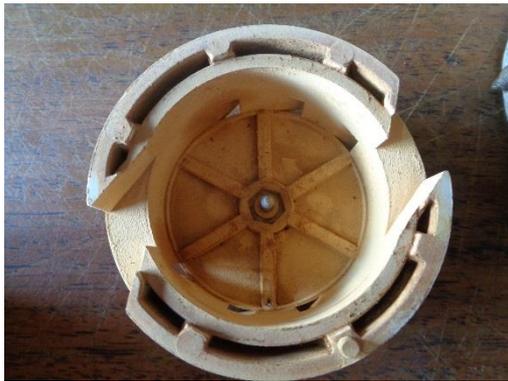
Vast majority of the rejected meters are stuck-up or dead meters. Sand particles, build-up of sediments and tiny solids are the main reasons why the water meters stopped spinning. Tampering is also one of the problems causing faulty water meters. Photos below show the findings observed from the stuck-up meters.

Photo 18: Sediments build-up in the Measuring Chamber

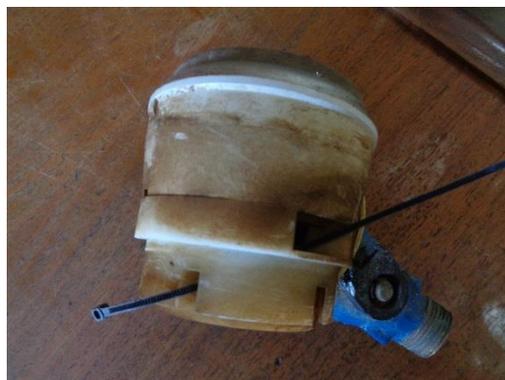
Photo 22: Meter Tampering (Insertion of Plastic Tie)

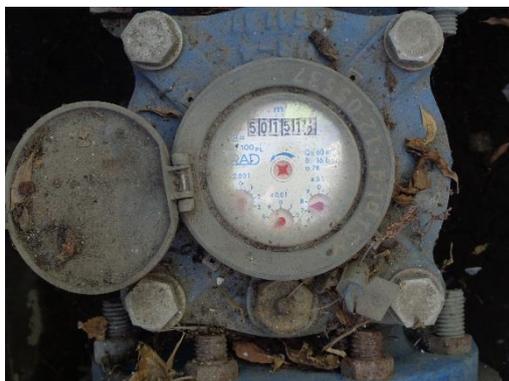
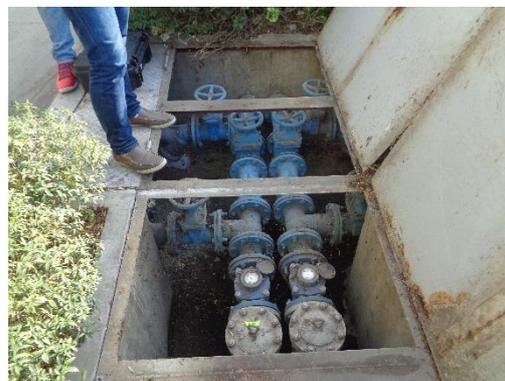
The meter of Centrio Mall and its assembly was inspected. It was found out that the meter does not have straight pipe distance on both sides and there was no strainer installed that can protect the meter from tiny debris or solids coming from the distribution network. The meter is properly sized with 3 years in service. The photos below show the Centrio Mall meter and its assembly.

Photo 26: Cagayan de Oro Gateway Corp. (Centrio Mall) Meter

Photo 27: Cagayan de Oro Gateway Corp. (Centrio Mall) Meter Assembly

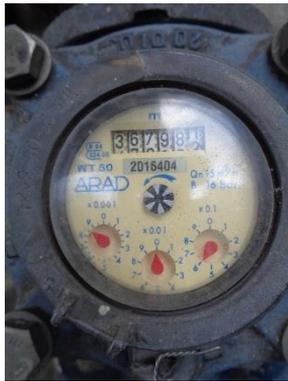
Photo 32: Chiu Roger Lim (Mall Berry Hotel) Meter

There was limited straight pipe distance observed on both sides of Mall Berry Hotel’s meter. Furthermore, there is no strainer in the meter set assembly. The meter is 10 years in service which needs immediate replacement. It is also slightly oversized.

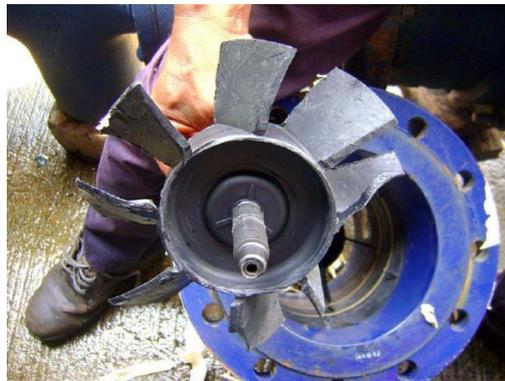
Photo 47: Damaged Turbine of the Large Customer Meter
