NRW MANAGEMENT STRATEGY

Technical Assistance to Cagayan De Oro City Water District on
Non-Revenue Water Reduction Strategy and Implementation

Subcontract Agreement No. 893-S15-013

September 2016

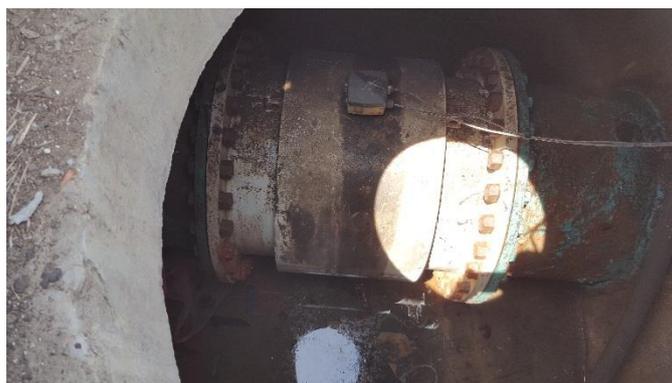
Photo 1: Rio Verde Supply Meter (10-Year Old Meter)

The average age of the supply meters installed in COWD supplied areas is 7 years. There has been no calibration and maintenance made on these meters in the past years. It is being said by COWD technician that there was a meter verification carried out by Tradepoints, a local distributor of Siemens products, couple of years ago for Siemens brand electromagnetic meters. However, Tradepoints only verified and checked the overall operability status of the parameter settings of Siemens electromagnetic meters and not their actual measurement accuracy.

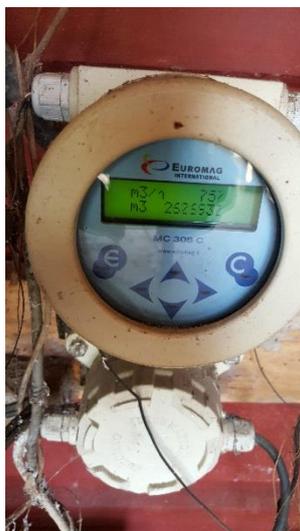
The existing supply meter installed in production well #18 has a problem with the display. Some of the digital segments on the character display are fading which makes it very hard to read. There is also problem on its converter as its totalizer continuously accumulates supply volume reading even though the production well is totally shut-off.

Photo 3: Fading Digital Segments (PW #18)

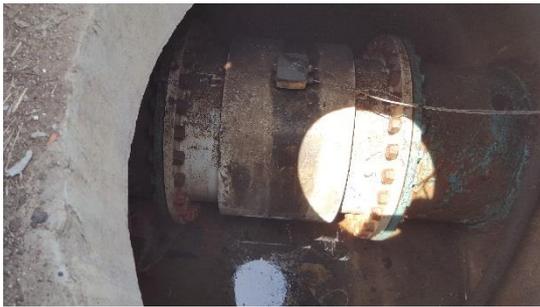
Photo 7: Rio Verde Supply Meter

The supply meter's nominal diameter size is within the acceptable size limit. With an average velocity of 1.1 m/s through the pipeline, the current supply meter should be able to measure the supply volume effectively. Based on the record, the age of this meter is 10 years. Therefore, this supply meter has to be checked and calibrated accordingly. The following photos show the Rio Verde's supply meter and official meter display.

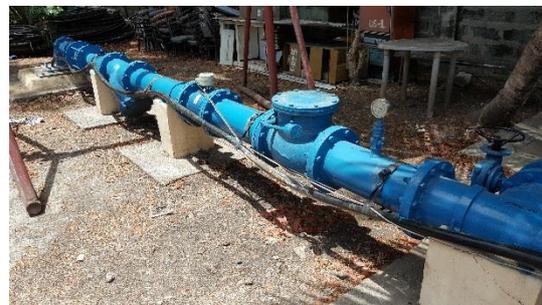
Photo 14: Production Well #10A Meter Assembly

There are no available straight pipe distances at both sides of the meter. The power/signal cables between the meter sensor and converter are stretched out which can break the internal wires and loose its signal in the long run (see Photo 13).

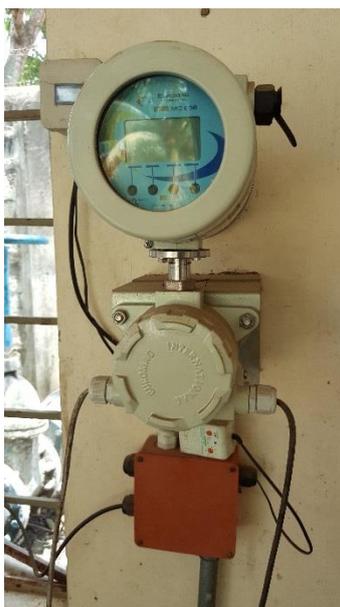
Photo 15: Production Well #10A Converter (Blackout Display)

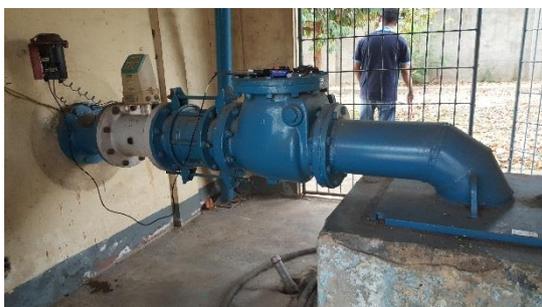
Photo 24: Production Well #5 Supply Meter Assembly

Due to the check valve fitted close to the meter, the upstream pipe section doesn't meet the required straight pipe allowance. The check valve's disk that opens and closes in varying line pressure could create flow distortion that can lead to inaccuracy of the supply meter. Having an average velocity of 1.17 m/s through the supply line, the current meter is properly sized and can be able to cover the supply variations. The succeeding photos show the supply meter assembly and converter of the production well #5.

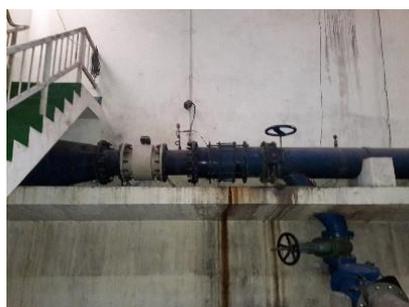
Photo 26: Bugo Booster Supply Meter

The current meter is properly sized. However, the meter doesn't have straight pipe distance on both sides. The presence of butterfly valve and set of pump motors located at the upstream side of Bugo Booster's supply meter could create swirls through the supply pipeline. This swirl is a flow distortion that can affect the reliability of the meter's measuring performance. A pipe reducer is also fitted at the downstream of the meter which also contributes to flow distortions. The meter is located at the elevated concrete platform which makes it very hard to maintain. The following photos show the supply meter and converter of Bugo booster.

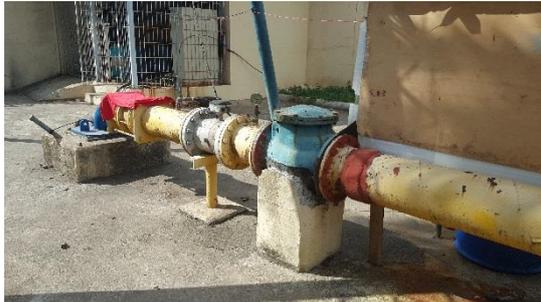
Photo 28: Production Well #23 Supply Meter Assembly

The current supply meter installed in production well #23 is properly sized. The meter assembly has limited straight pipe spacing on both sides. The photos below show the supply meter and assembly of production well #23.

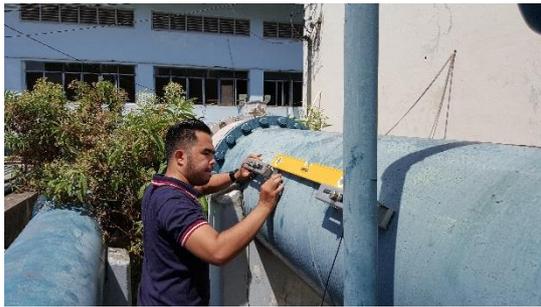
Photo 35: Actual Installation of Clamp-on Ultrasonic Meter at Macasandig Old Booster Bank #1

The logged flow data for the month of April 2016 shows sudden flow fluctuations which has never been occurred in the past three months. This could be due to the alarm that has manifested in the same month where the fluctuations were observed. However, this needs to be checked and verified by accredited Siemens technician to further understand the source and effect of the alarm.

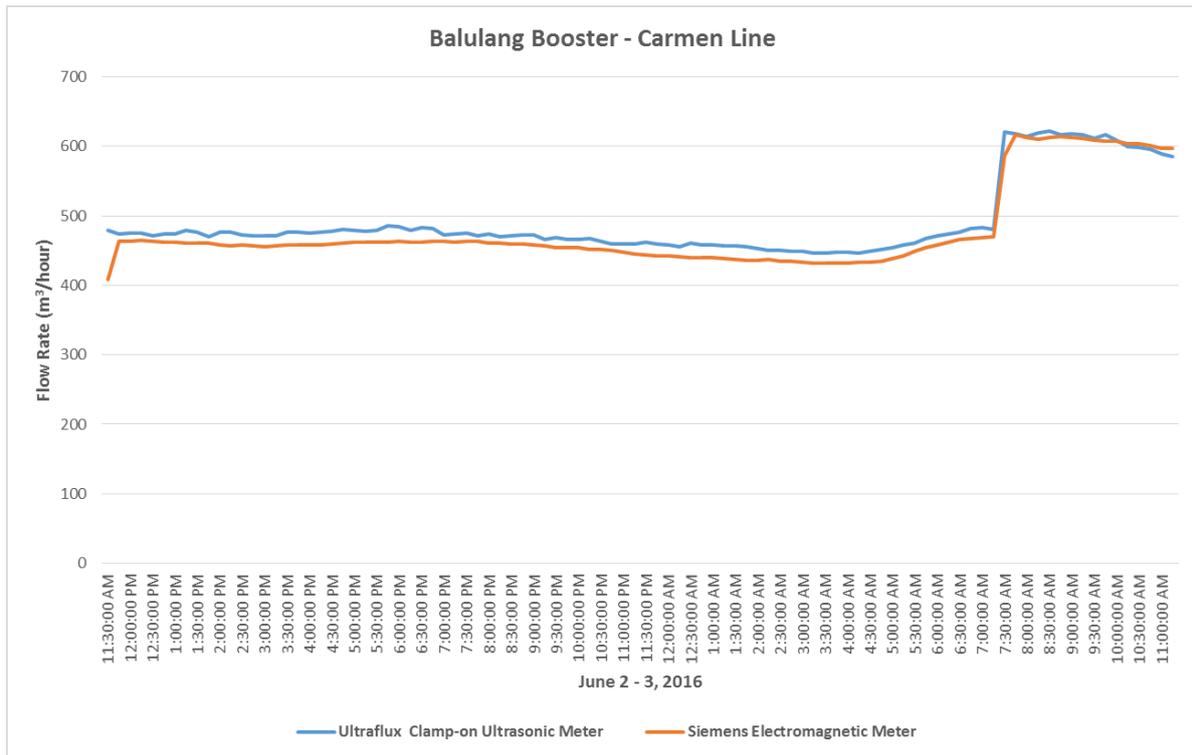
Figure 3: Carmen Line Meter – Flow Measurement Comparison

There is a 2.8% measurement variance between the reference meter and the meter under test. On the graph, the reference meter, which is the ultrasonic meter, measured more water supply compare to the meter under test. This means that the meter under test or the supply meter is under-registering by 2.8% with respect to the reference meter. The following photo shows the actual installation of the reference meter at Carmen line.

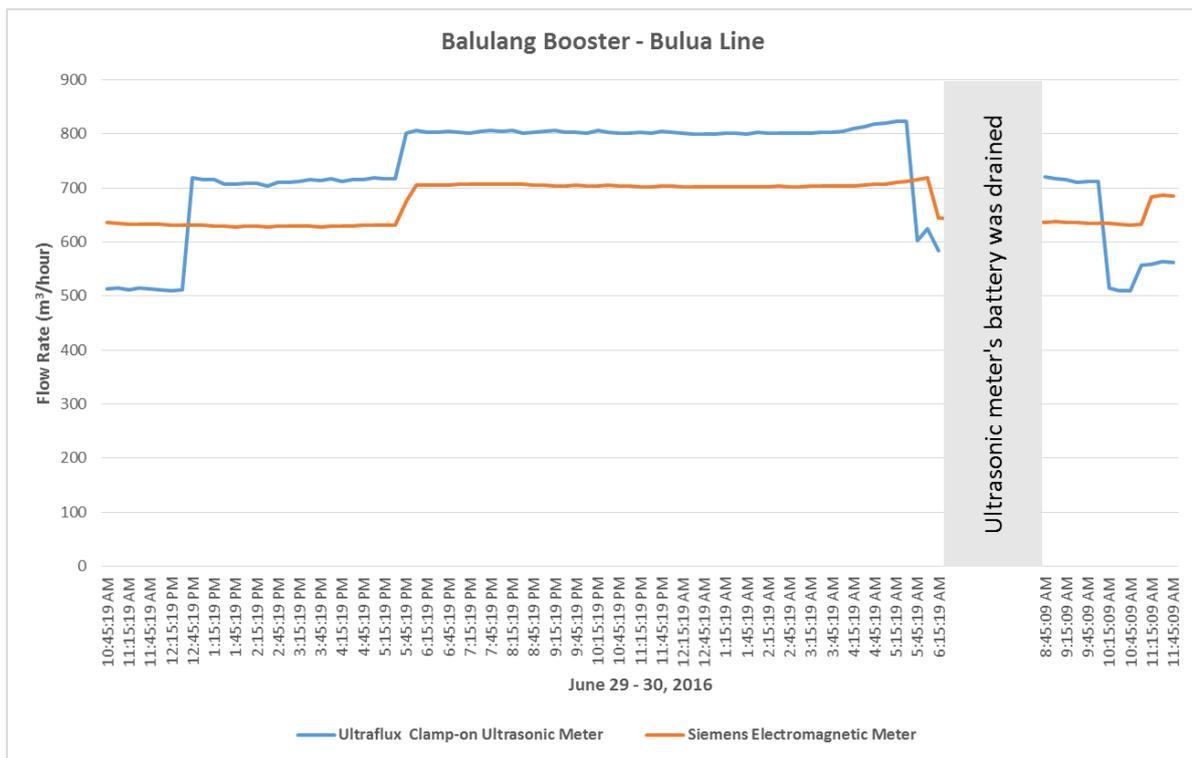
Figure 5: Bulua Line Meter – Flow Measurement Comparison

There is a 7.9% measurement variance between the reference meter and the meter under test. On the graph, the reference meter which is the ultrasonic meter measured more water supply compare to the meter under test. This means that the meter under test or the supply meter is under-registering by 7.9% with respect to the reference meter. The comparison graphs of the reference meter and meter under test can be seen in the following figure.

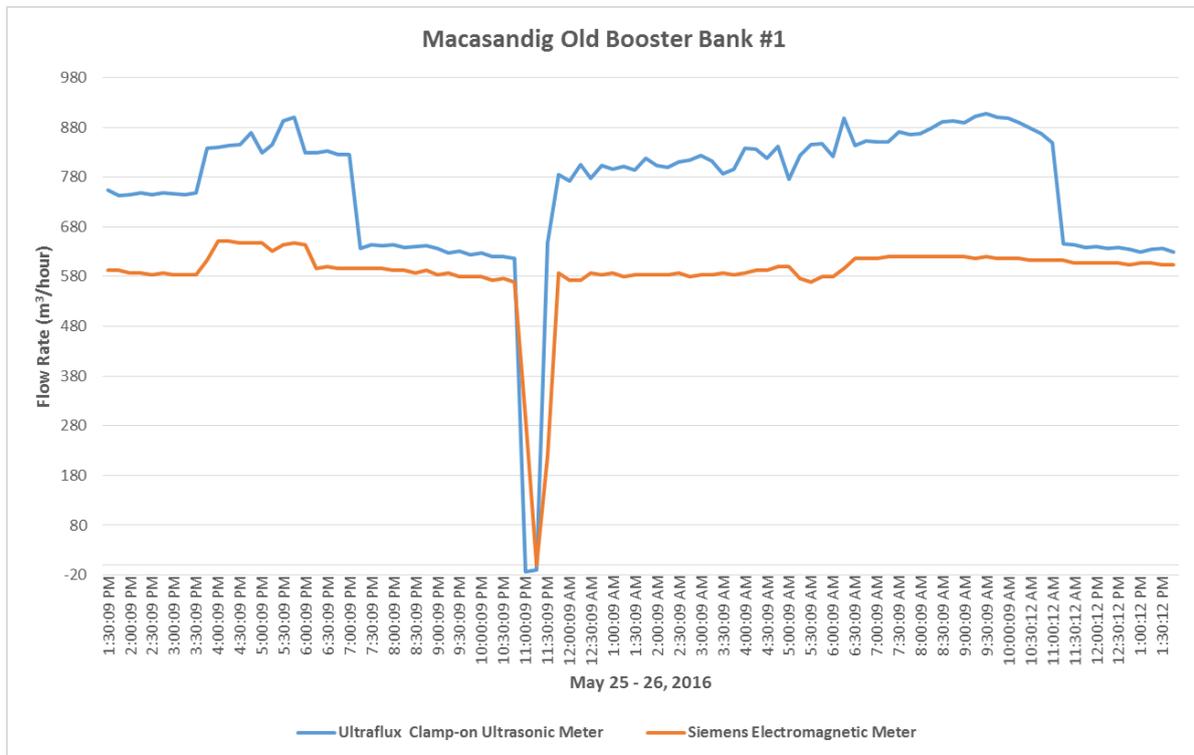
Figure 7: Macasandig Old Booster Bank #1 Meter – Flow Measurement Comparison

Based on the results, the supply meter installed in Macasandig old booster bank #1 line is significantly under-registering by 29%. However, the under-registration rate changes between the time windows of 1915H to 2245H and 1130H to 1345H where the under-registration rate varies between 8% to 5%. In principle, the electromagnetic meter’s accuracy is almost consistent (linear) at any flow velocities. These extreme variations on the supply meter’s accuracy might have to do with the alarm that has

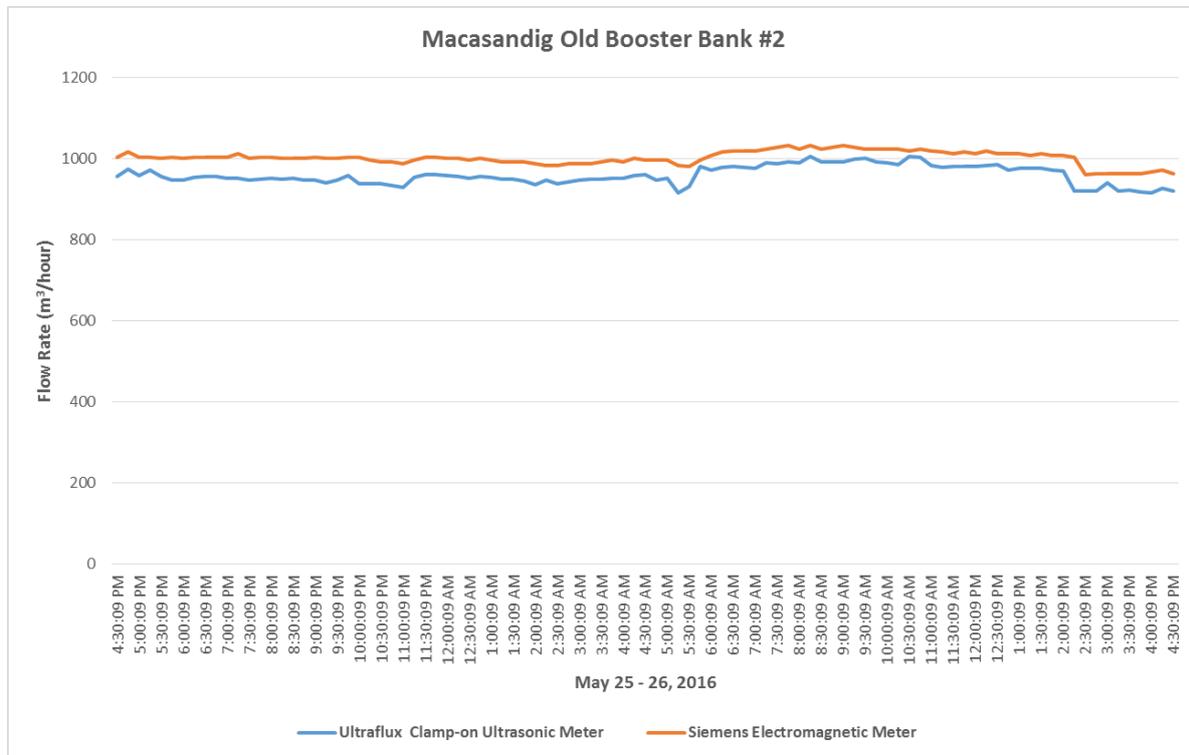
Figure 8: Macasandig Old Booster Bank #2 Meter – Flow Measurement Comparison

There is a 4.3% measurement variance that observed after the water supply measurements from the meter under test (supply meter) was compared to the reference meter. The supply meter, which is the meter under test, measured more water supply compare to the reference meter (ultrasonic meter). Therefore, it is over-registering by 4.3%. The variance in meter registration rate observed on

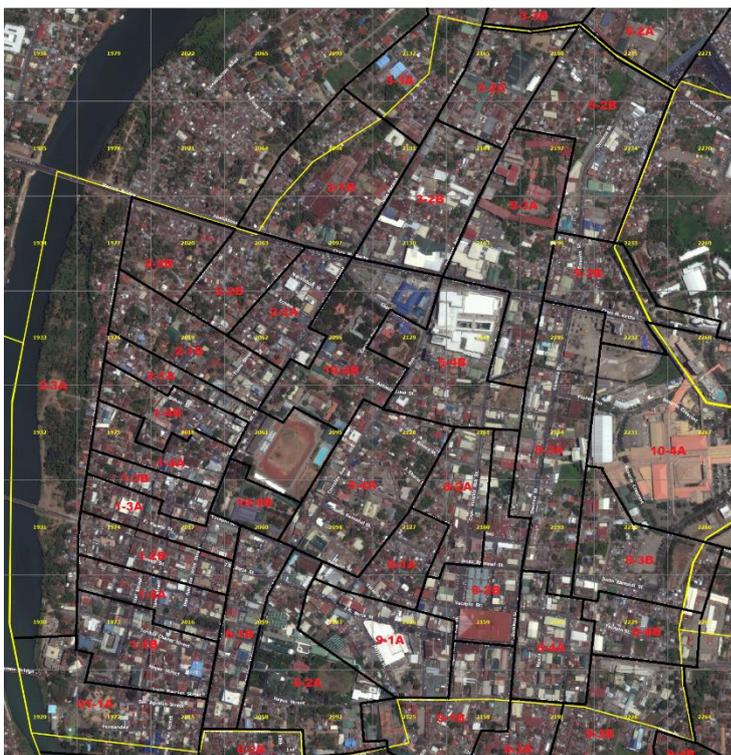
Photo 6: Poblacion Area

This particular area was also used as basis in determining the number of non-horizontal installed meters. It was found out that about 18% of the water meters within Poblacion area were installed in non-horizontal position.

- Poor water meter readability: 1,652 (25%)
- Water meters without seal: 2,193 (33%)
- Water meter located inside the customer property: 1,685 (26%)

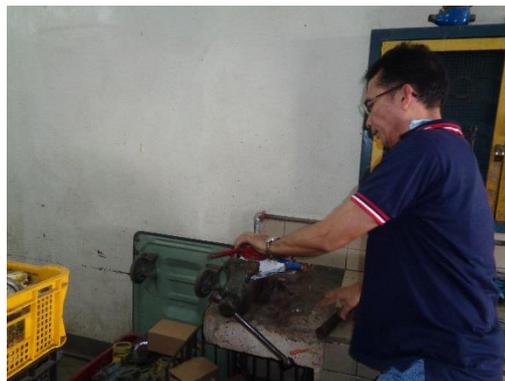
Photo 17: Actual Dismantling of Rejected Water Meter

Water meters that displayed erratic error results have a problem with the synchronization of the dials that can misled the meter readings. Water meters with faulty dials and blurry lens were observed during the physical inspection carried-out on the sample water meters. Faulty dials occurred on the water meters because they had reached their wear and tear. However, in some cases, the meters are exposed to high flow rates for a long period of time that leads to faster rate of wear and tear.

The moisture entrapped inside the meter lens due to worn-out internal gaskets gets the meter lens looked blurry. Another reason is that those water meters with plastic lens get faded as plastic degrades its composition when continuously exposed to direct sunlight.

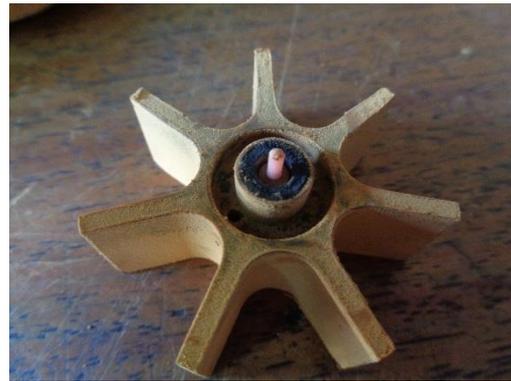
Photo 19: Sediments build-up on the Impeller

Build-up of sedimentation inside the wall of measuring chamber and impeller creates high friction resulting to meter stoppage. Sand particles particularly iron content in it builds on the magnetic coupler attached on the meter's impeller. The iron particles block the magnetic transmission of both magnetic couplers fixed at the impeller and register side. This condition causes the water meter to under-register.

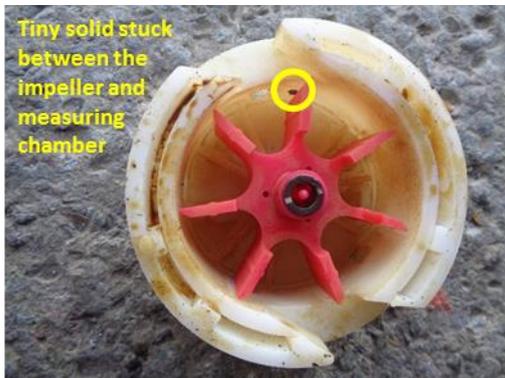
Vast majority of the rejected meters are stuck-up or dead meters. Sand particles, build-up of sediments and tiny solids are the main reasons why the water meters stopped spinning. Tampering is also one of the problems causing faulty water meters. Photos below show the findings observed from the stuck-up meters.

Photo 20: Stuck-up Impeller due to Tiny Solid

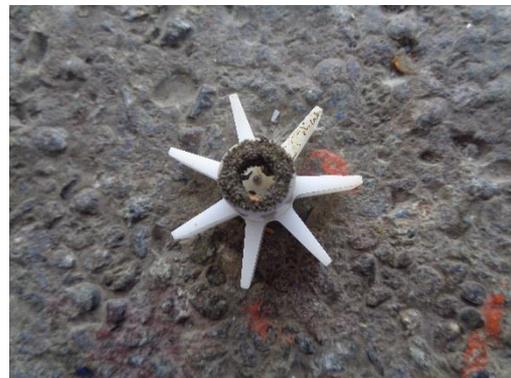
Photo 21: Sand Particles on the Magnet Coupler

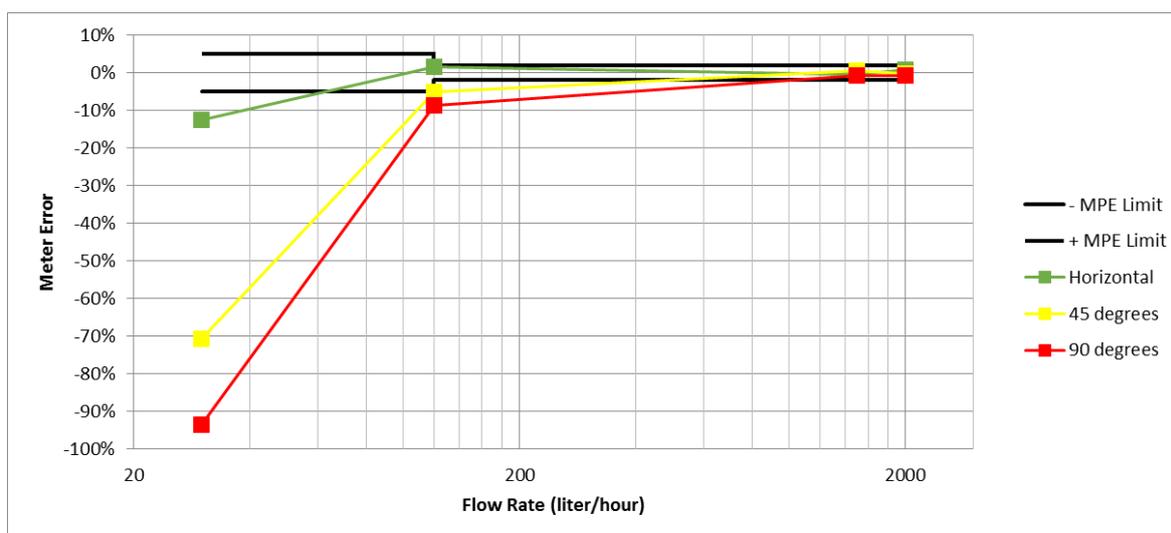
Figure 3: Error Curve of the Water Meter at Different Meter Orientations

The test results showed that the orientation (positioning) of water meters has direct effect on their meter errors. When the meters are installed at 45 and 90 degrees orientation, it significantly under-registers the water consumption especially at low flow zones. This typically happened on the velocity meters such as multijet and single type meters. It was observed during test that even the new water meters were also affected by this phenomenon. Furthermore, the older the meter, the higher the chance it will under-register when installed in non-horizontal orientation. In COWD particularly in Poblacion Area, there is roughly 18% of the total water meters that are installed in non-horizontal position based on the census survey data. Non-horizontal installations would definitely contribute to the inaccuracy of the water meters. Therefore, it has to be considered in the final calculation of the overall meter under-registration.

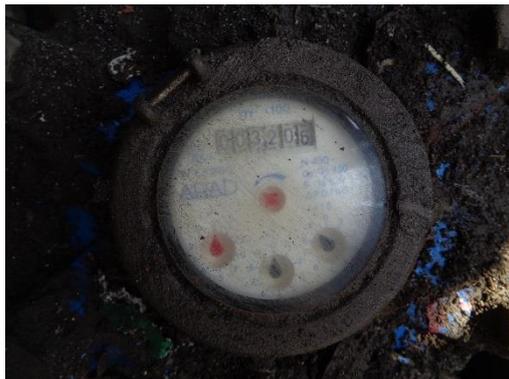
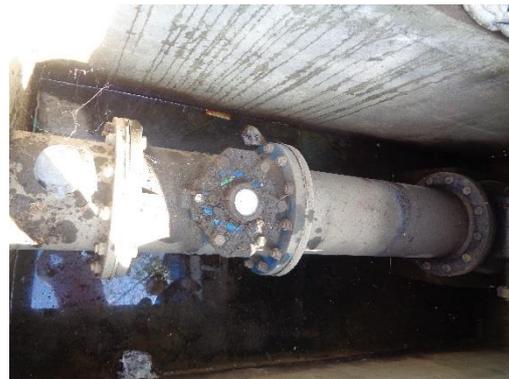
Philippine Port Authority PMO CDO (PPA) is the COWD’s top two (2) largest customer with an average monthly consumption of around 11,700 m³. It produces Php 480,000 revenue every month. During the field inspection, there was no strainer found in the meter assembly. There is good straight pipe distance on both sides of the meter. The meter is oversized that may lead to considerable under-registration most especially at low flow consumptions. The photos below show the PPA meter and its assembly.

Photo 28: Philippine Port PMO CDO Authority Meter

Photo 29: Philippine Port PMO CDO Authority Meter Assembly

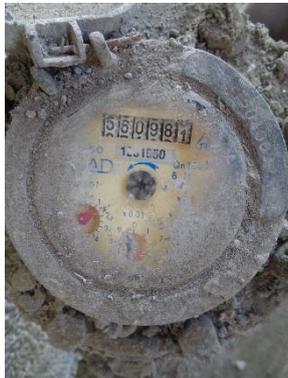
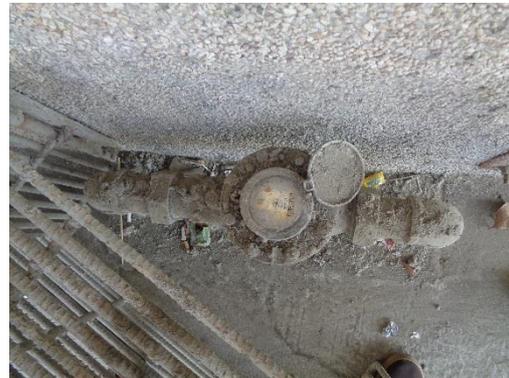
The meter is slightly oversized. There was a limited straight pipe distance on both sides meter. No strainer found during the field inspection. It also observed that the meter dial was slightly jerking which could be an indication that there might be a problem on the meter’s internal mechanism. The meter installed is already 12 years in service that needs immediate replacement. The succeeding photos shows the Limketkai’s meter and its assembly.

Photo 30: Limketkai Sons Inc. Meter

Photo 31: Limketkai Sons Inc. Meter Assembly

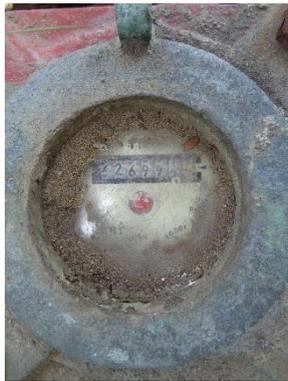
Limited pipe straight pipe distances have found on both sides. No strainer was installed in the assembly. The meter installed is slightly oversized. Rust build-up has been observed on the meter body. The meter register has been covered by dirt and fogging that makes it very difficult to read. These observations lead to immediate replacement of the meter in Capitol College General Hospital.

Photo 34: Capitol College General Hospital Meter

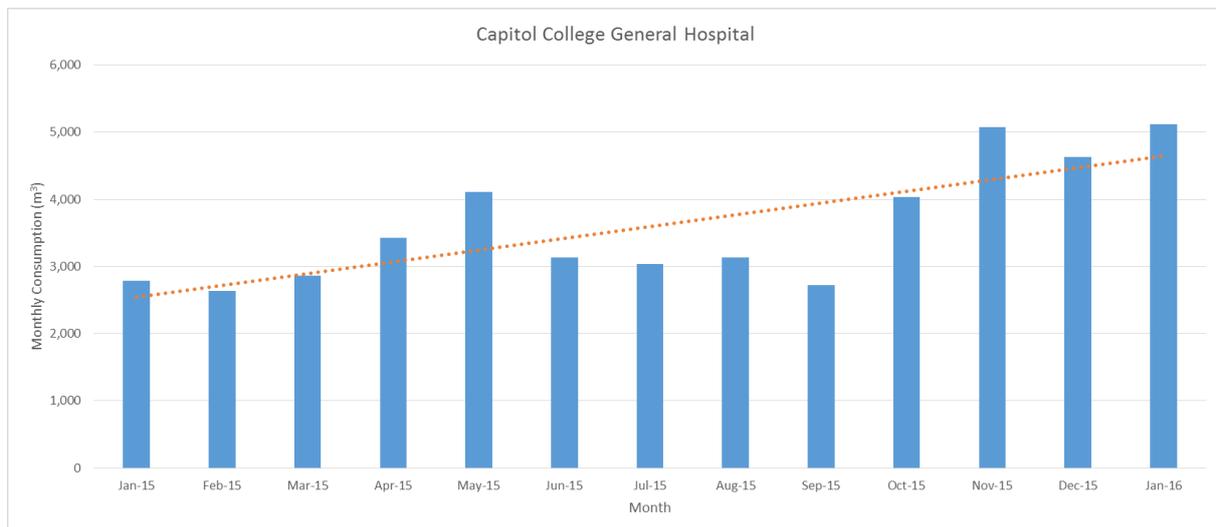
Figure 8: Capitol College General Hospital Historical Monthly Consumption

An upward consumption trend has been observed after graphing out the 1-year historical monthly consumption. The past monthly consumption of Capitol College General Hospital can be seen in the succeeding figure.

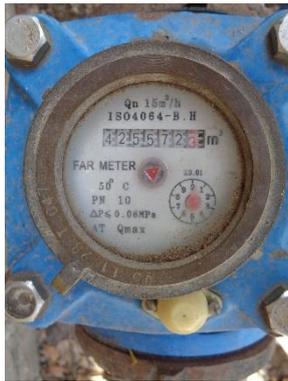
Photo 36: MOGCHS N DAEL Meter

The meter is slightly oversized. There was a limited straight pipe distance on both sides. No strainer was found during the field inspection. It also observed that the meter dial was jerking which could be an indication that there might be a problem with the meter’s internal mechanism. The meter installed is already 4 years in service and is located inside the school premise. Immediate meter replacement and relocation are highly recommended. The succeeding photos shows the MOGCHS’s meter and its assembly.

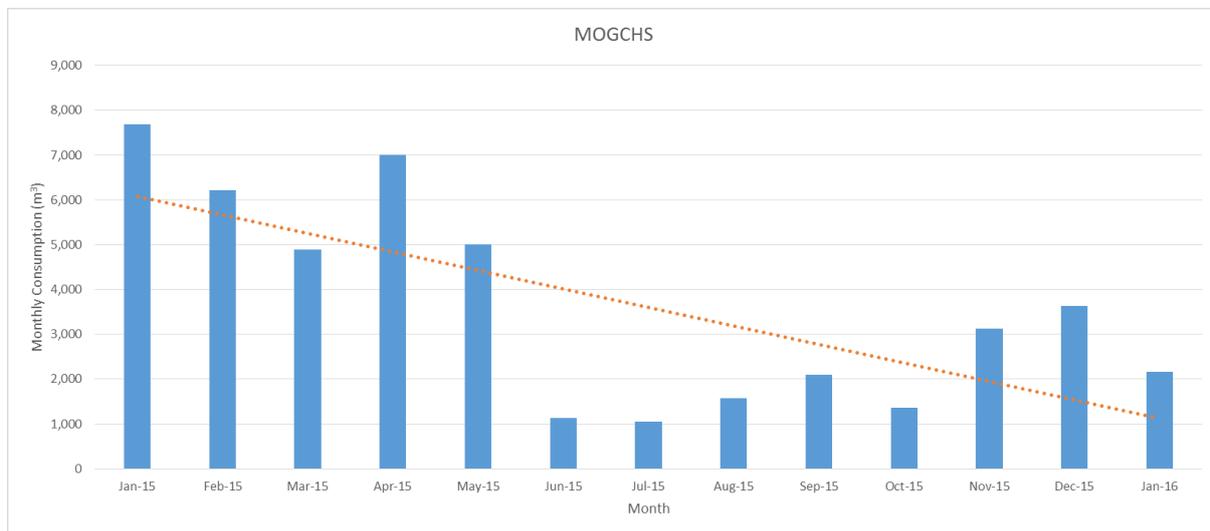
Figure 9: MOGCHS Historical Monthly Consumption

An abrupt decrease in monthly consumption has been observed starting June 2015. This can be an indication that the meter has degraded its accuracy. The figure below shows the graphical representation of MOGCHS 1-year historical monthly consumption.

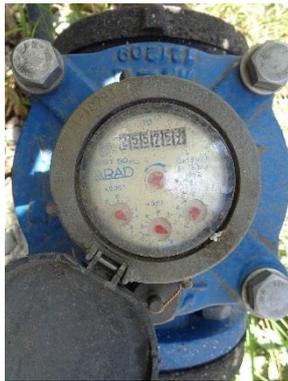
Photo 38: Northern Mindanao Medical Meter

The meter is slightly oversized. There was a limited straight pipe distance on both sides. No strainer was found in the meter assembly. The meter installed is already 13 years in service that needs immediate replacement. The succeeding photos shows the Northern Mindanao Medical’s meter and its assembly.

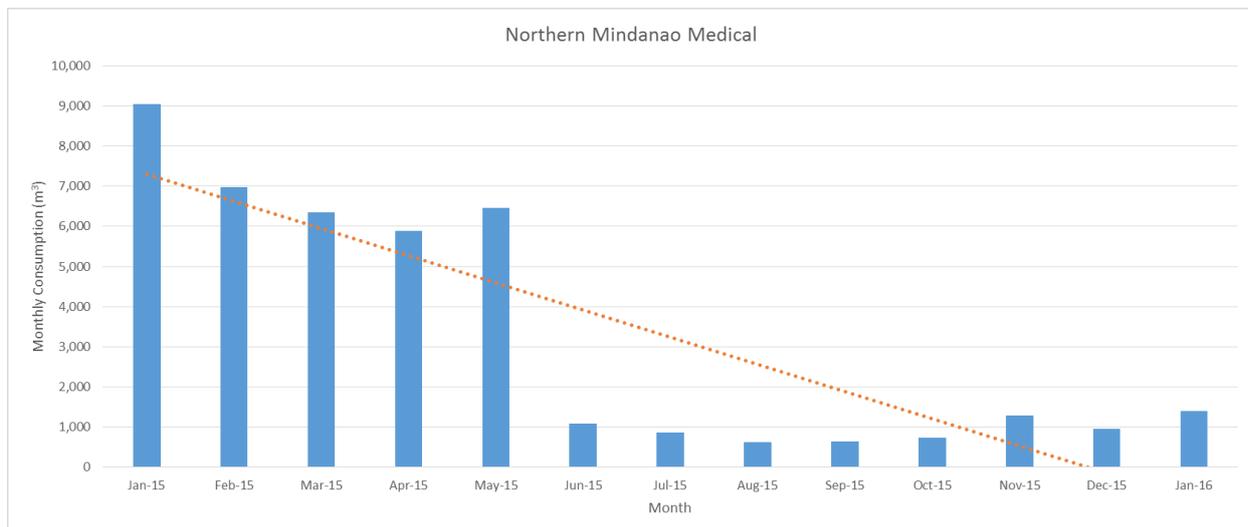
Figure 10: Northern Mindanao Medical Historical Monthly Consumption

There has been significant decreased in consumption which was observed starting June 2015. This consumption decline might have to do with the inaccuracy of the meter considering that it is too old. The figure below shows the historical monthly consumption of Northern Mindanao Medical.

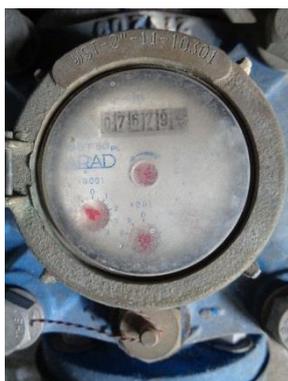
Photo 40: PC INP RECOM 10 Meter

The meter is slightly oversized. There was a limited straight pipe distance on both sides. No strainer was found in the meter assembly. The customer uses pump (at the downstream side of the meter) as the area could not get enough water due to low pressure level. The installed pump could create flow distortion that may affect the measuring performance of the meter. The meter installed is 3 years in service. The succeeding photos shows the Northern Mindanao Medical’s meter and its assembly.

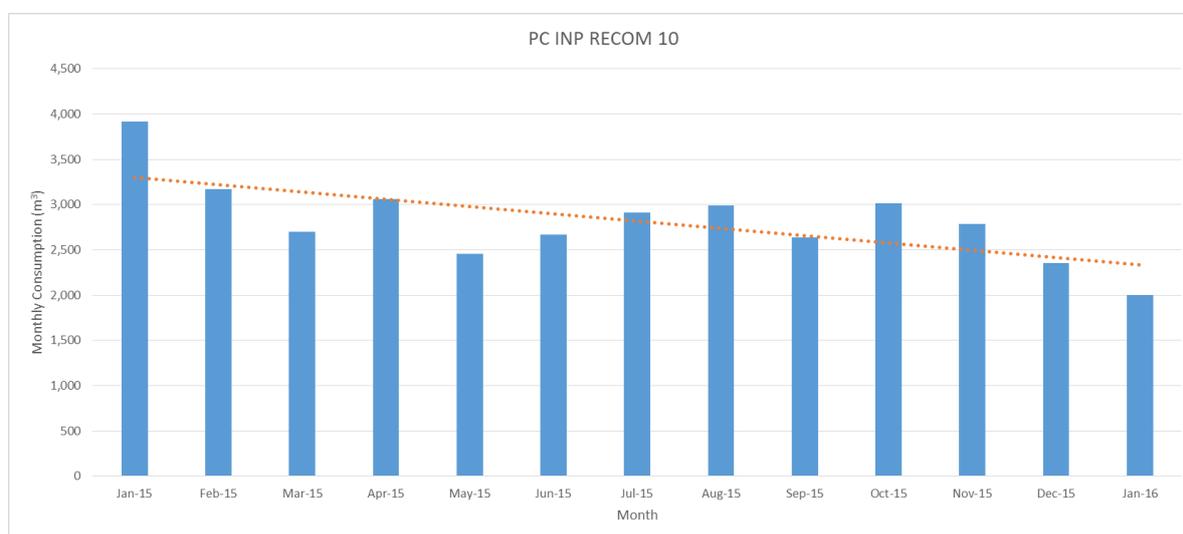
Figure 11: PC INP RECOM 10 Historical Monthly Consumption

A decreasing trend in monthly consumption has been observed that might have to do with the existing low-pressure level in the area or could be due to meter’s degrading accuracy. The figure below shows the 1-year historical monthly consumption of PC INP RECOM 10.

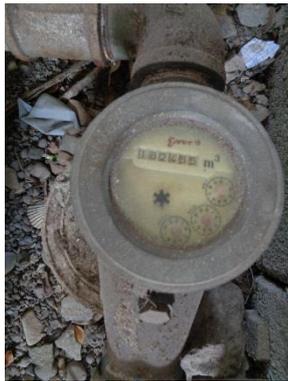
Photo 42: Chaves Juanito Lim (CHALI Resort) Meter

The meter is oversized. It was found out during the inspection that this meter is defective. The meter installed is already 15 years in service and is located inside the school premise. Immediate meter replacement and relocation are highly recommended. The succeeding photos shows the CHALI’s meter and its assembly.

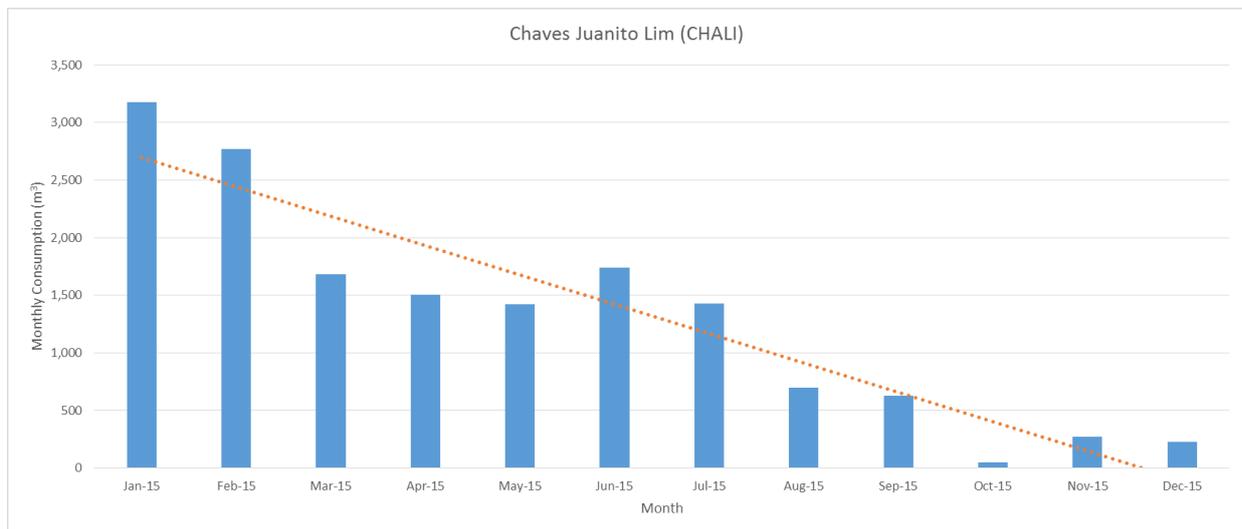
Figure 12: Chaves Juanito Lim Historical Monthly Consumption

A significant decline in the monthly consumption has been observed which started in August 2015. These could be the months when the meter started to lose its accuracy. The succeeding figure shows the 1-year historical monthly consumption of CHALI Resort.

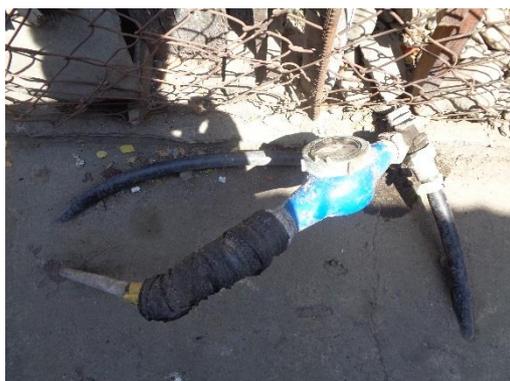
Photo 44: Provincial Jail Off. Mis. Or. Meter

The meter is slightly oversized and it is installed in non-horizontal position. A meter installed in non-horizontal position could result in significant under-registration most especially at low flow consumption. The meter installed is already 8 years in service and is located inside the prison premise. Immediate meter replacement and relocation are highly recommended. The succeeding photos shows the Provincial Jail’s meter and its assembly.

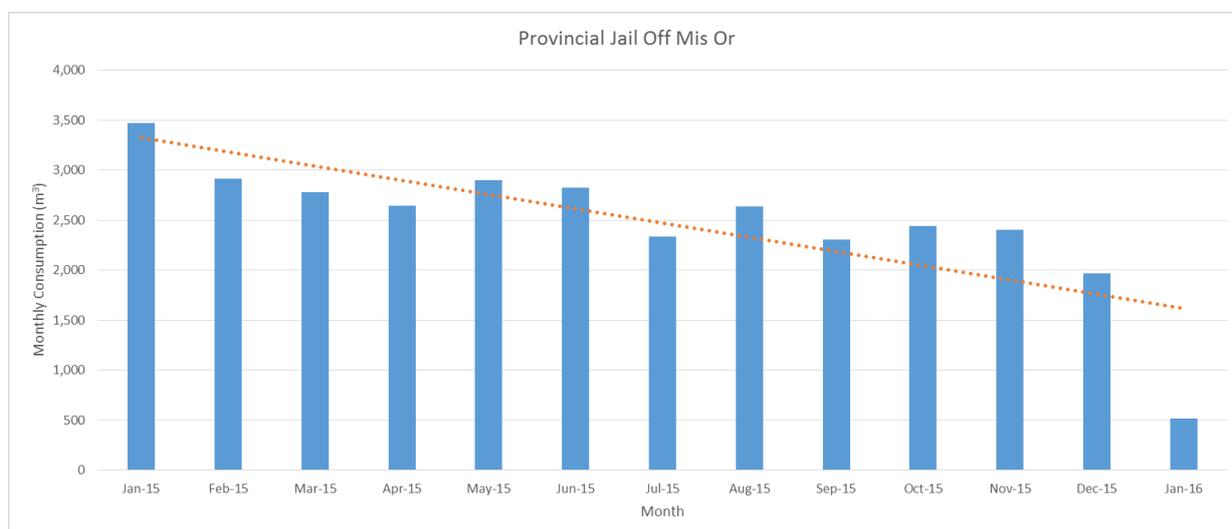
Figure 13: Provincial Jail Off. Mis. Or. Historical Monthly Consumption

There has been significant decreased in consumption which was observed starting January 2016. This consumption decline might have to do with the inaccuracy of the meter considering that it is too old. The figure below shows the historical monthly consumption of Provincial Jail Off. Mis. Or.

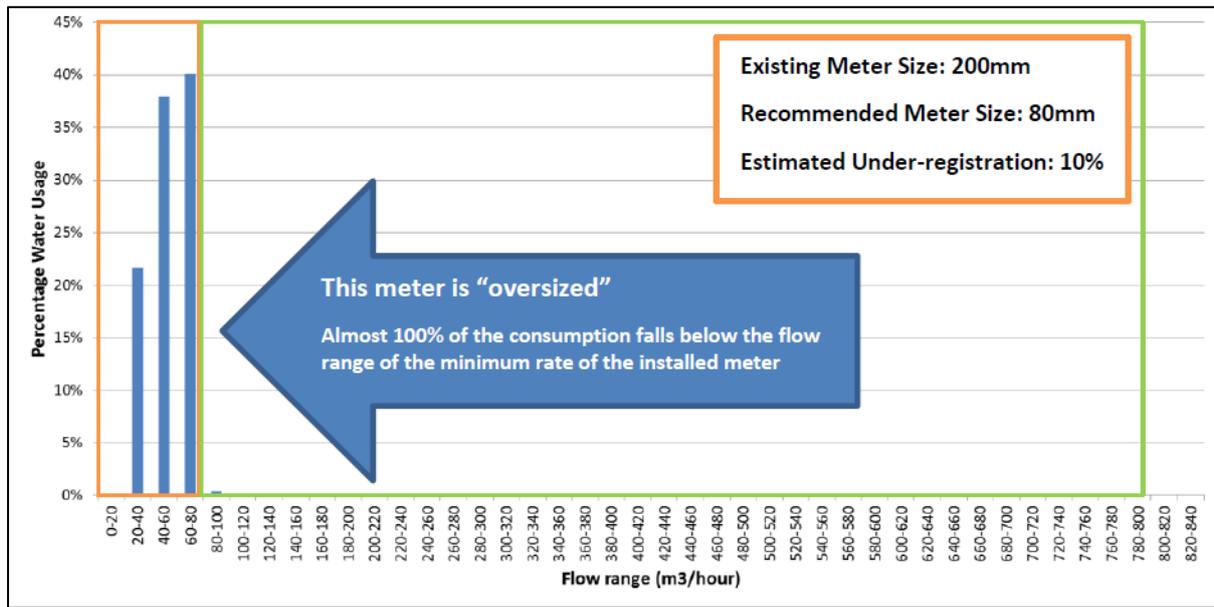
If the water meter is oversized: the demand pattern of the customer will definitely fall within or under the rated starting or minimum flow rates of the water meter and this will result to significant meter under-registration. The figure below shows the demand pattern of a large manufacturing plant in Dar es Salaam City, Tanzania (Africa). The entire demand pattern of this particular customer falls below the minimum flow rate of the existing water meter due to over-sizing. This leads the meter to under-register the billed consumption by approximately 10%.

Figure 14: Effect of the Oversized Meter

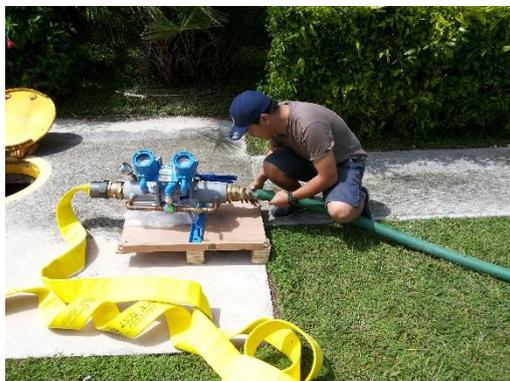
Photo 48: Actual In-situ Meter Accuracy Testing

After the in-situ accuracy testing had carried-out, it was revealed that the meter is under-registering by 29% that leads to revenue loss of about USD 108,000 annually.
